UNITED STATES ENVIRONMENTAL PROTECTION AGENCY
REGION 1
1 Congress Street, Suite 1100
BOSTON, MA 02114-2023

Memorandum

Subject: Whitney Barrel Inspection, 256 Salem Street, Woburn, MA

FIGURES – EPA Inspection of Whitney Barrel Property, Woburn, MA

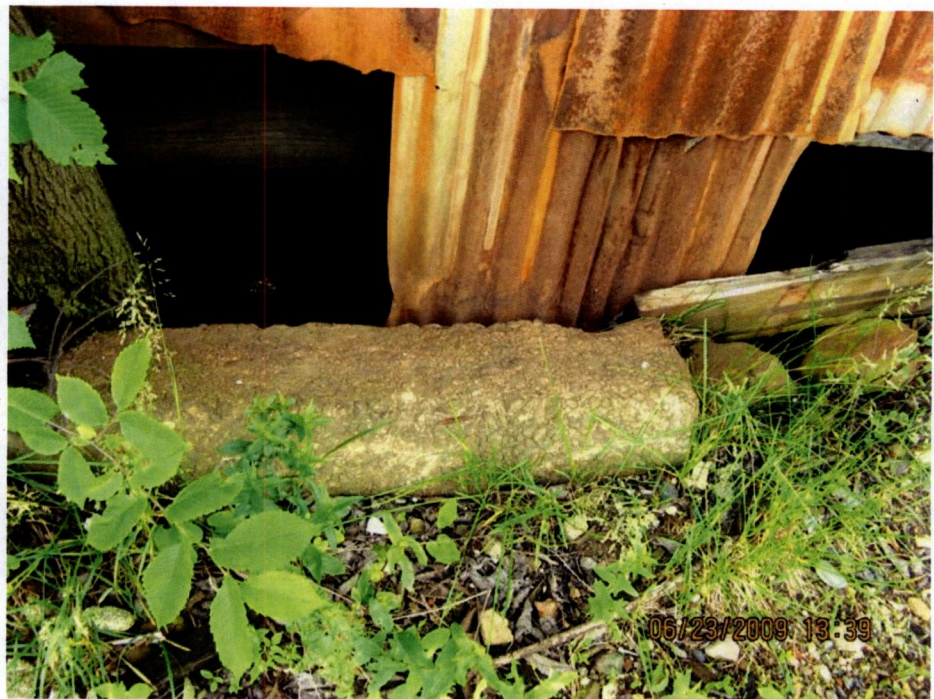
28. Gap between the building and foundation showing standing water underneath the building.

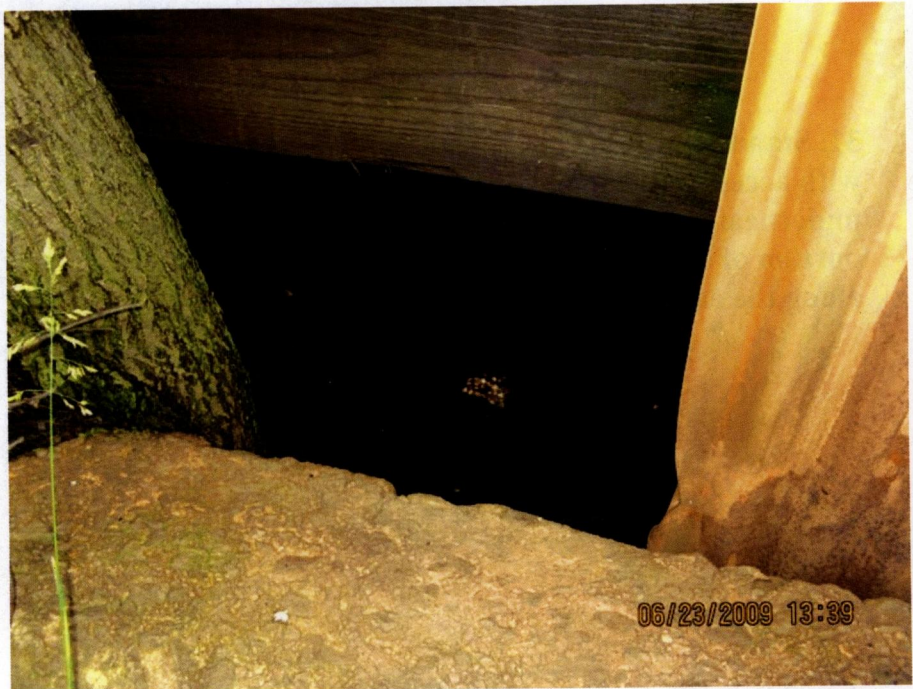
**29. Same gap showing
standing water
directly underneath
the building**

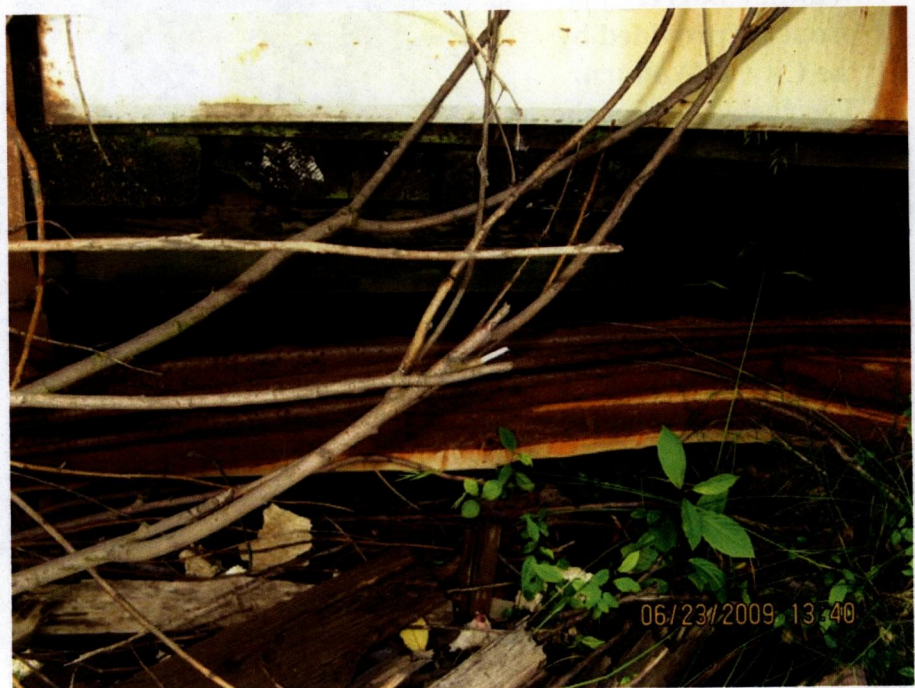
**30. Debris in front of
another gap between
the building and
foundation along the
eastern side of the
building**

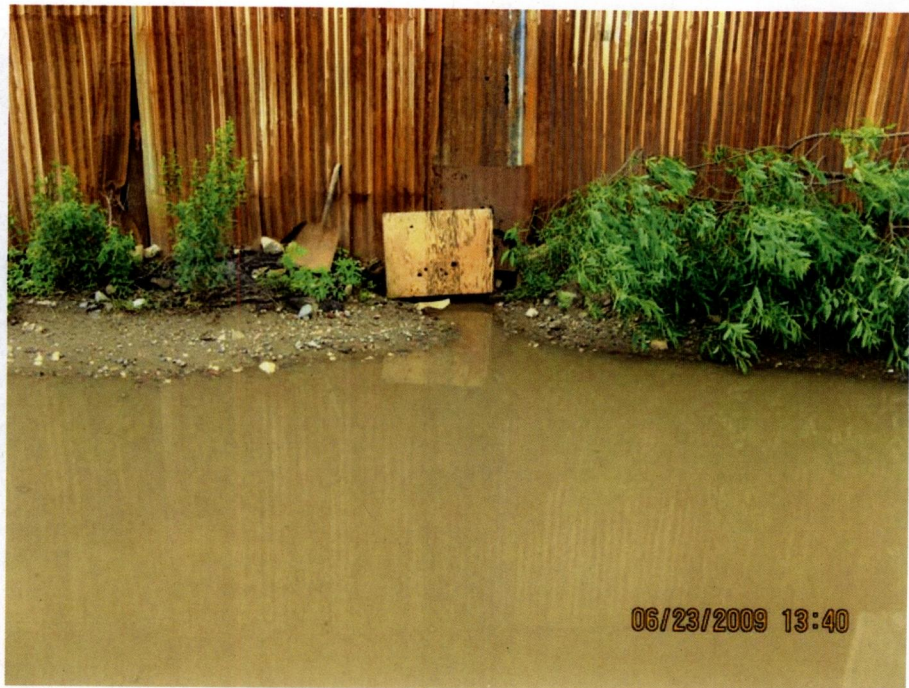
31. Standing water with access to the gap underneath southern portion of building along the eastern wall

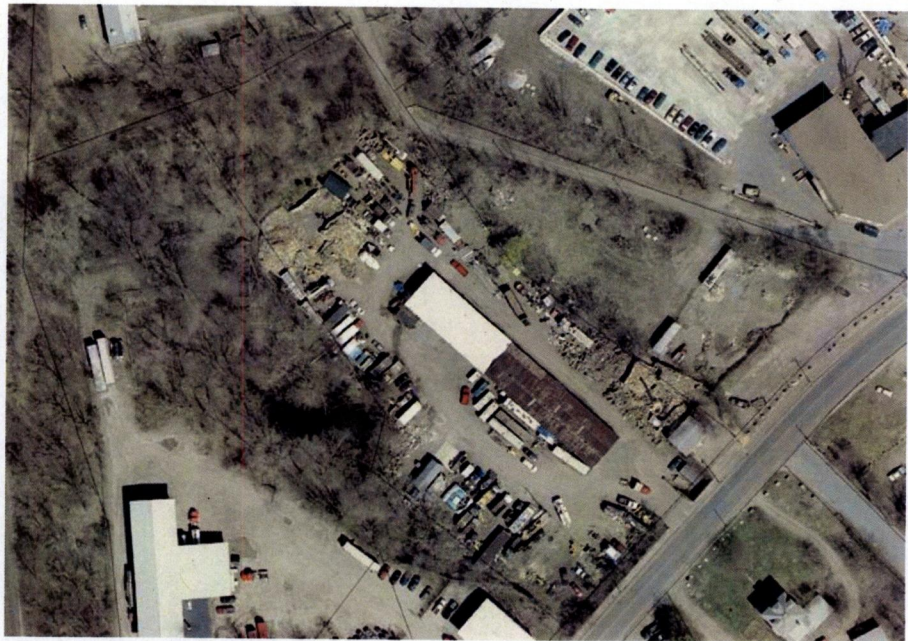
On June 24th, EPA also contacted the Woburn City Engineers Office regarding the 256 Salem Street. The Engineering office maintains the City's GIS and Assessor maps. The Engineering office provided EPA two aerial photographs of the property. The most recent was dated 2006 and closely resembles the current conditions on the property. See photograph 32.

32. 2006 aerial photograph of Whitney Barrel property provided by the City of Woburn. The rusted roof of the southern portion of the building and white roof of the northern portion of the building are clearly visible in the photograph. The 4 trailers (3 side by side) are visible at the southwest corner of the southern portion of the building, and represent their current location on the property. A greater degree of debris is visible along the east side of the property.
